9PCO RM 137

FX - AIR PATROLS

3FZ → DETAILED INSPECTIONS

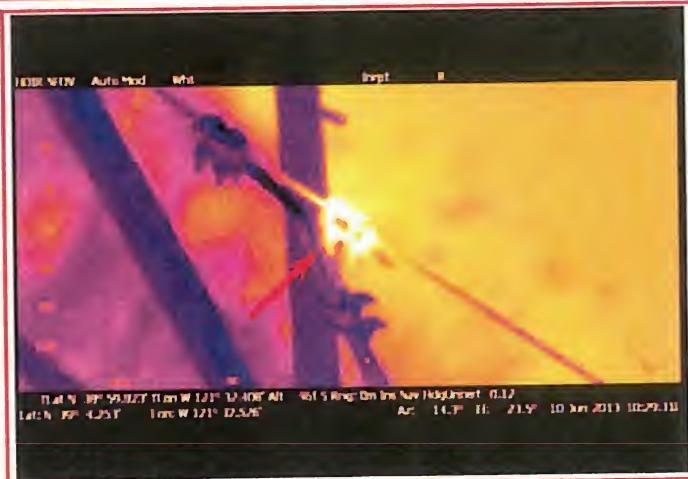
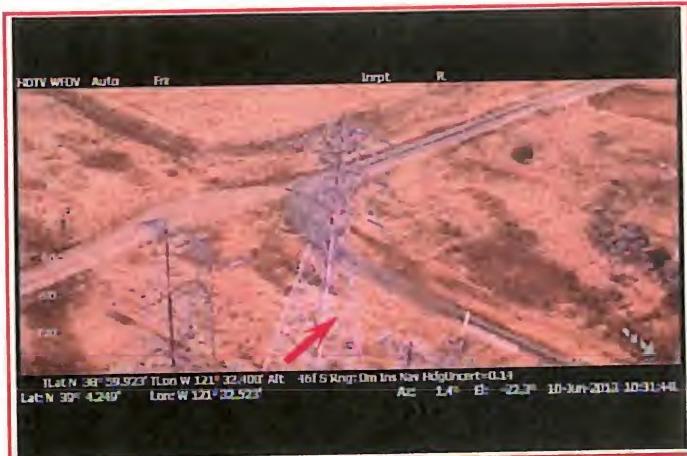
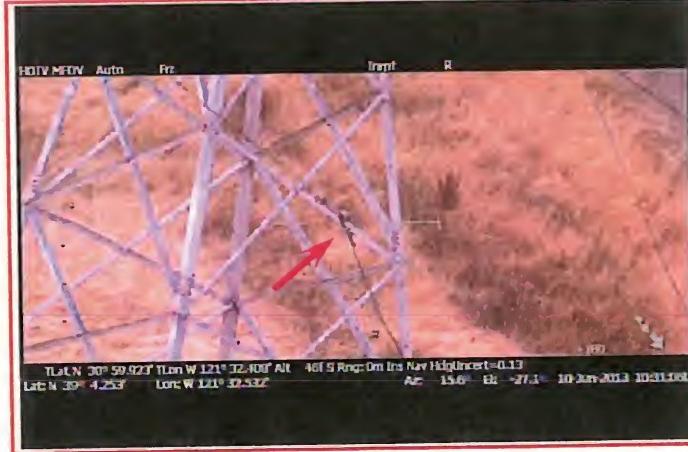
REPLACE U-BOLT CONNECTORS W/ AMP CONNECTORS <i>Showing hot on Infrared, Jumper between T 29/211 & T 0/1A</i> <i>Replaced all 3 levels of u-bolt conn. to Amps.</i>			
Completed by Dawn (Name and LAN ID):		Date: 7/17/13	Actual Labor-Hours:
Reviewed by JH (Name and LAN ID):		Date: 6/19/13	PM # 41916411

Severity of Problem: III (Intermediate)

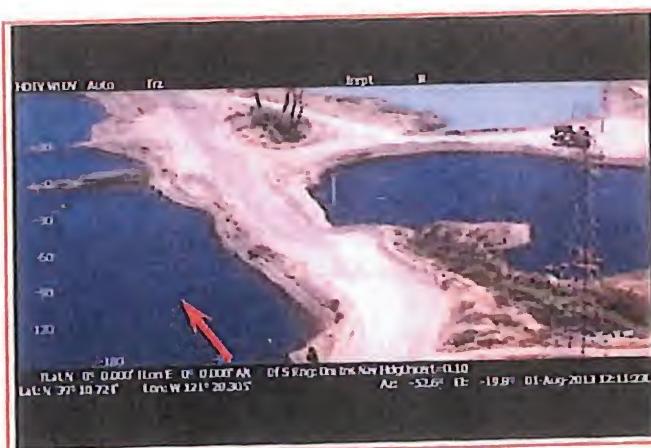
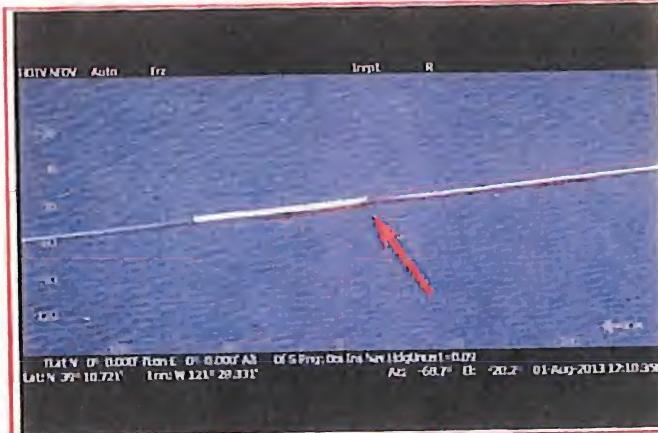
* 08/09/2013 09:36:34 Aida Luna (AXRU) Phone 530/896-4277					
* per buck arden on 8/1/2013 during an IR patrol found hot sleeve bottom					
* phase.

Severity of Problem: III (Intermediate)

* _____					
* 08/15/2013 11:08:14 Christina Dangerfield (CLD9) Phone 916/386-5422					
* CORRECTION TOP PHASE, 73/475 - 73/476,					
* _____					
Completed by: (Name and LAN ID): <i>Romy</i>		Date: 08/01/2013		Actual Labor-Hours:	
Reviewed by (Name and LAN ID): <i>JTA</i>		Date: 10-21-13

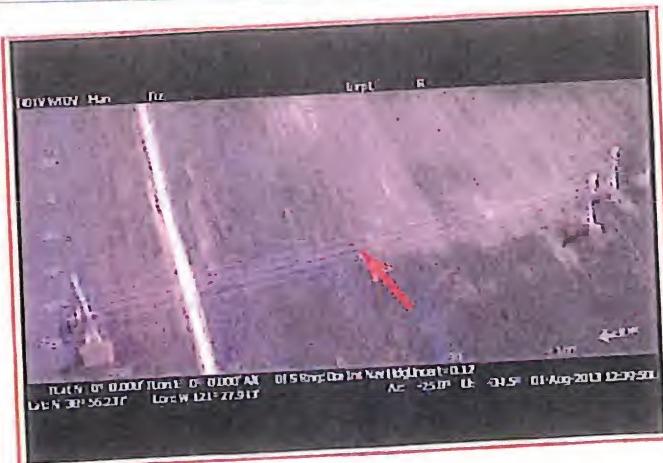
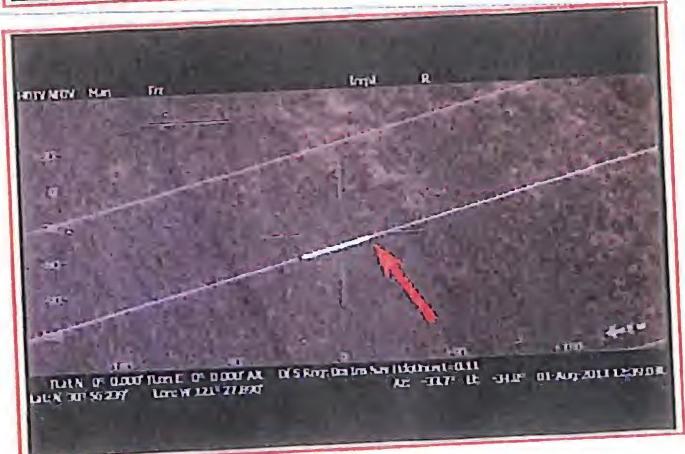
* 08/09/2013 09:37:56 Aida Luna (AXRU) Phone 530/896-4277				
* per buck arden during an ir patrol found hot sleeve bottom phase				
Completed by: (Name and LAN ID): <i>JTA6</i> <i>20MY</i>	Date: 08/01/2013 <i>10-14-13</i>	Actual Labor-Hours:		
Reviewed by: (Name and LAN ID): <i>JTA6</i>	Date: 11 <i>10-21-13</i>

Severity of Problem: III (Intermediate)
